# Access Compliance Report Public Rights-of-Way (Curb Ramps)

Main Street: LIVINGSTON\_AVE Cross Street: WESTON\_PL Location: SW

ADA ID: RPAT211001140830 Ramp Type: Type 1 - Perpendicular Diagonal Initial Pass/Fail: Pass Overall Compliance: Yes Severity Score: 0

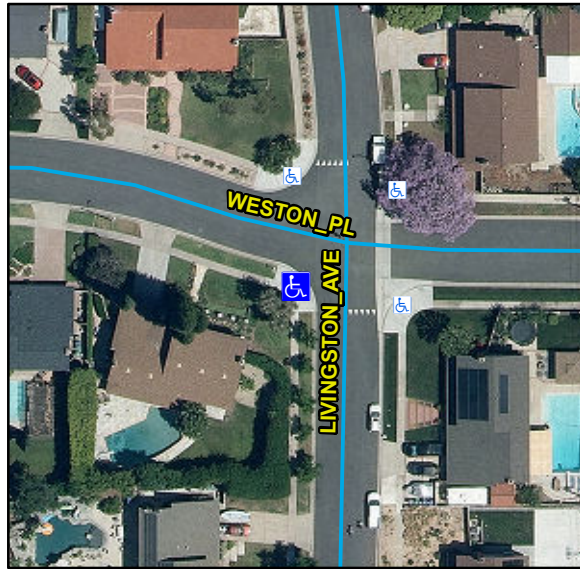
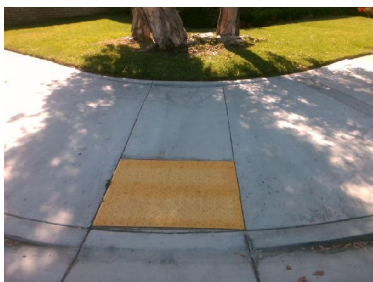
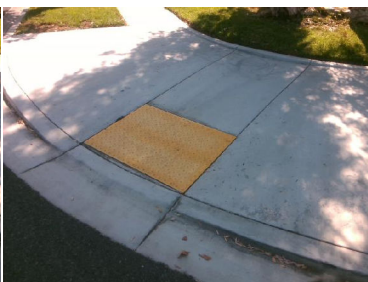
| Compliance | Description | Data | Compliance | Description | Data |
|---|---|---|---|---|---|
| Yes | Overall Surface Condition: Acceptable | | Yes | Perp Joint Present | Yes |

N/A
