# Access Compliance Report Public Rights-of-Way (Curb Ramps)

Main Street: HOLT\_AVE Cross Street: WARREN\_AVE Location: NE

ADA ID: RPAT211004132443 Ramp Type: Type 1 - Perpendicular Diagonal Initial Pass/Fail: Pass Overall Compliance: Yes Severity Score: 0

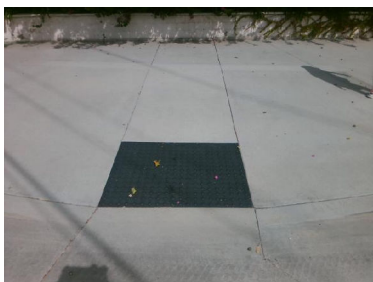
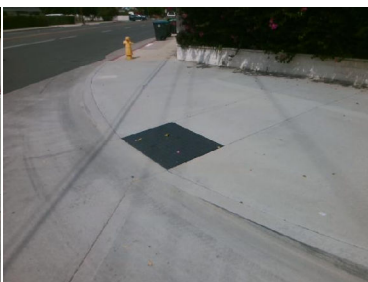
| Compliance | Description | Data | Compliance | Description | Data |
|---|---|---|---|---|---|
| Yes | Overall Surface Condition: Acceptable | | Yes | Perp Joint Present | Yes |
