# Access Compliance Report Public Rights-of-Way (Curb Ramps)

Main Street: ARBOLADA\_WAY Cross Street: HOWLAND\_WAY Location: NW

ADA ID: RPAT211004152033 Ramp Type: Type 1 - Perpendicular Diagonal Initial Pass/Fail: Pass Overall Compliance: No Severity Score: 0

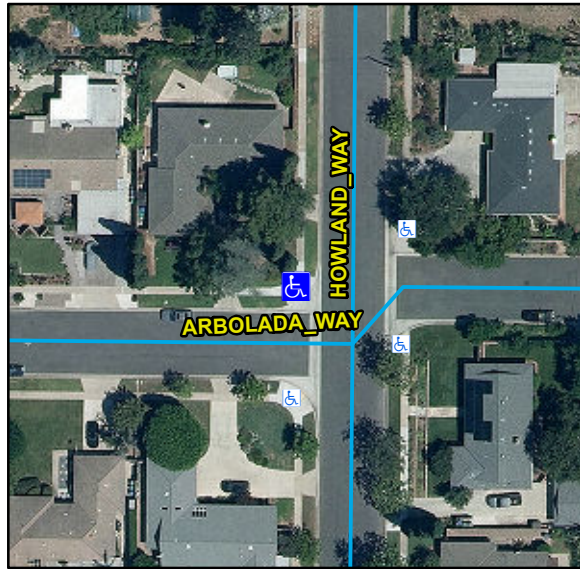
| Compliance | Description | Data | Compliance | Description | Data |
|---|---|---|---|---|---|
| Yes | Gutter Ponding | No | No | Curb Slope | 5.1 |

Remove & Replace Curb Slope.

R304.2.2, STD 1115
