# Access Compliance Report Public Rights-of-Way (Curb Ramps)

Main Street: DUNAS\_RD Cross Street: CASSELLE\_AVE Location: NE

ADA ID: RPAT211005095629 Ramp Type: Type 1 - Perpendicular Diagonal Initial Pass/Fail: Pass Overall Compliance: No Severity Score: 20

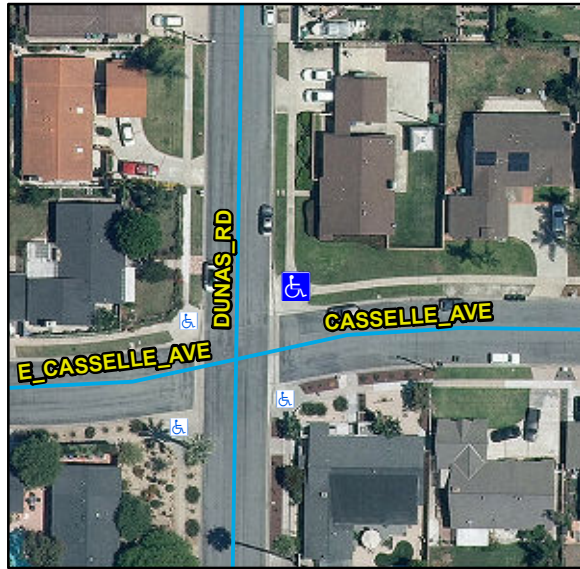
| Compliance | Description | Data | Compliance | Description | Data |
|---|---|---|---|---|---|
| No | Landing Width (in) | N/A | N/A | Flare Slope RT (%) | 6 |
| No | Landing Run Slope (%) | N/A | N/A | Flare Traversable RT | No |
| No | Landing Cross Slope (%) | N/A | No | DWS Provided | No |
| Yes | Gutter Ponding | No | No | Curb Slope | 7.3 |

Remove & Replace Curb Ramp With Two New Directional Ramps or Equivalent.

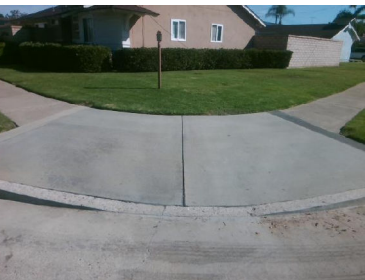
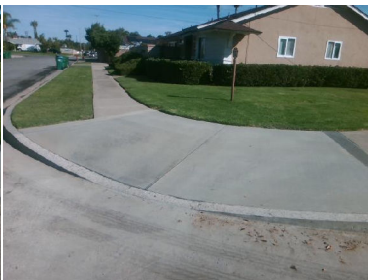
| Compliance | Description | Data | Compliance | Description | Data |
|---|---|---|---|---|---|
| Yes | Overall Surface Condition: Acceptable | | No | Perp Joint Present | No |
