# Access Compliance Report Public Rights-of-Way (Curb Ramps)

Main Street: SWIDLER\_PL Cross Street: LARKSTONE\_DR Location: NE

ADA ID: RPAT211005123135 Ramp Type: Type 1 - Perpendicular Diagonal Initial Pass/Fail: Pass Overall Compliance: No Severity Score: 22

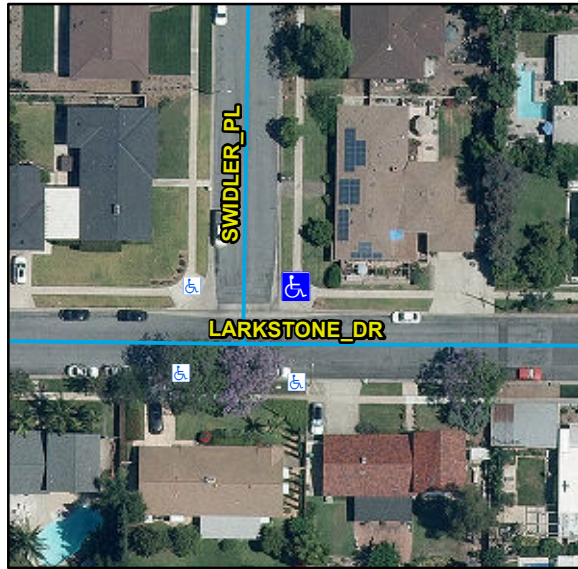
R304.2.2, R204.3, R304.2.1, R304.2.2-Perp, R304.3.2-Para, R304.5.3, R305, STD 1115

Remove & Replace Curb Ramp With Two New Directional Ramps or Equivalent.
