# Access Compliance Report Public Rights-of-Way (Curb Ramps)

| Main Street: ROLLINGSTONE_LN | | Cross Street: CHIRPING_SPARROW_WAY | | Location: | SW |
| ADA ID: RPAT211008124608 | Ramp Type: Type 4 - Parallel | Initial Pass/Fail: Pass | Overall Compliance: No | Severity Score: | 2 |

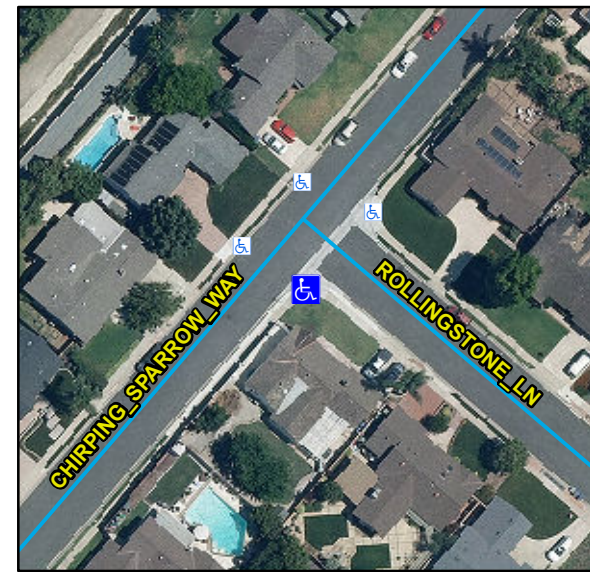
R304.2.2, STD 1115

| Compliance | Description | Data | Compliance | Description | Data |
|---|---|---|---|---|---|
| Yes | Gutter Ponding | No | No | Curb Slope | 14.2 |

Remove & Replace Curb Slope.

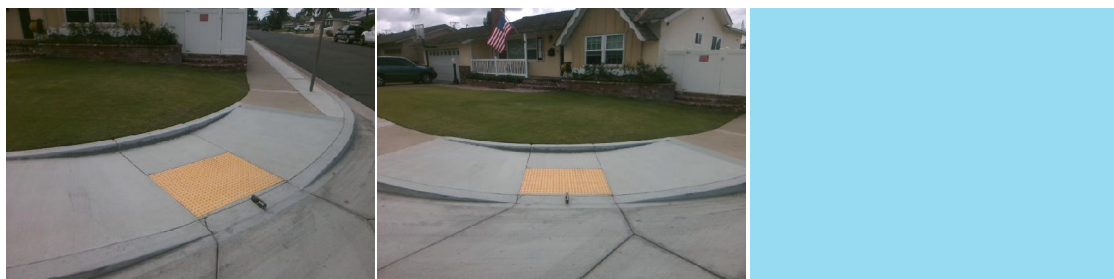
| Compliance | Description | Data | Compliance | Description | Data |
| N/A | Ramp Length LT (in) | 88 | N/A | Ramp Length RT (in) | 95 |
| Yes | Ramp Width LT (in) | 70 | Yes | Ramp Width RT (in) | 72 |
| Yes | Ramp Run Slope LT (%) | 6.6 | Yes | Ramp Run Slope RT (%) | 4.8 |
