# Access Compliance Report Public Rights-of-Way (Curb Ramps)

Main Street: CHIRPING\_SPARROW\_WAY Cross Street: RUNNING\_BRANCH\_WAY Location: SE

ADA ID: RPAT211008125227 Ramp Type: Type 4 - Parallel Initial Pass/Fail: Pass Overall Compliance: No Severity Score: 0

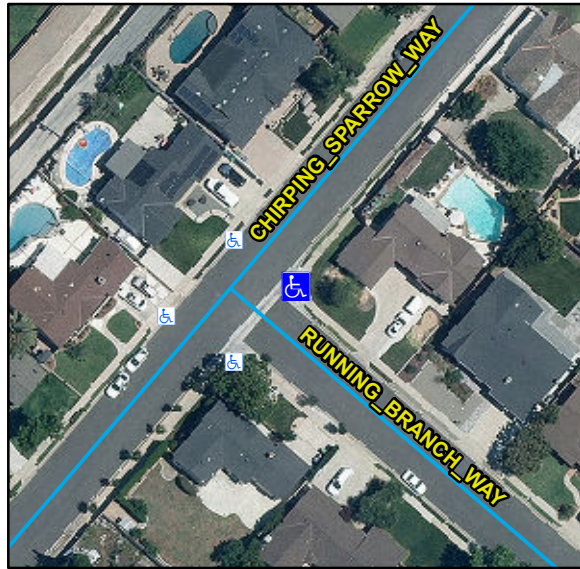
| Compliance | Description | Data | Compliance | Description | Data |
|---|---|---|---|---|---|
| Yes | Gutter Ponding | No | No | Curb Slope | 10.3 |

Remove & Replace Curb Slope.
