# Access Compliance Report Public Rights-of-Way (Curb Ramps)

| Main Street: RUNNING_BRANCH_WAY | | Cross Street: CHIRPING_SPARROW_WAY | | Location: | SW |
| ADA ID: RPAT211008125831 | Ramp Type: Type 4 - Parallel | Initial Pass/Fail: Pass | Overall Compliance: Yes | Severity Score: | 0 |

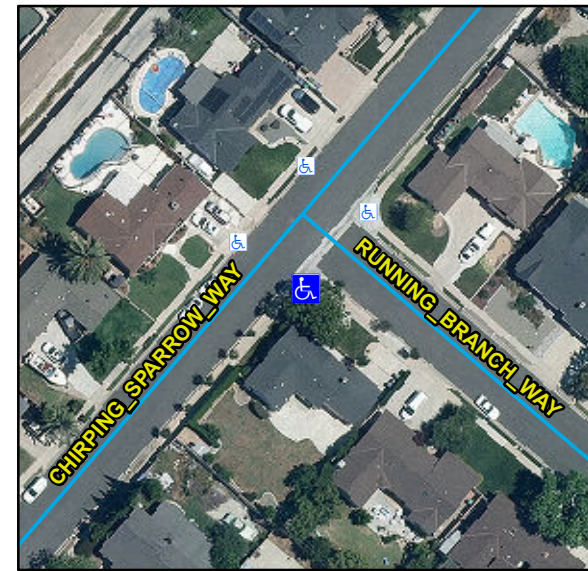
Surveyor Notes:

N/A

Possible Solutions:

N/A

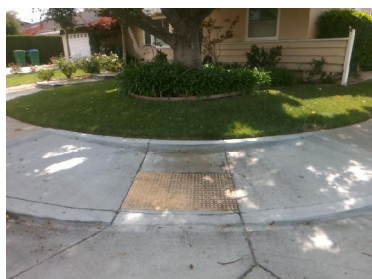
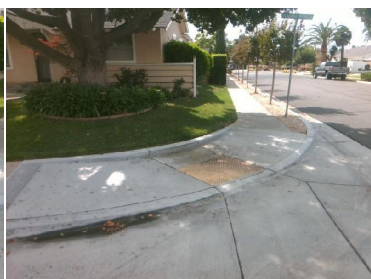
| Compliance | Description | Data | Compliance | Description | Data |
|---|---|---|---|---|---|
| N/A | Ramp Length LT (in) | 91 | N/A | Ramp Length RT (in) | 87 |
| Yes | Ramp Width LT (in) | 70 | Yes | Ramp Width RT (in) | 70 |
| Yes | Ramp Run Slope LT (%) | 5.5 | Yes | Ramp Run Slope RT (%) | 4.2 |
| Yes | Ramp Cross Slope LT (%) | 1 | Yes | Ramp Cross Slope RT (%) | 0.5 |
| Yes | Landing Width (in) | 49 | Yes | DWS Length (in) | 36 |
| Yes | Landing Run Slope (%) | 1.9 | Yes | DWS Full Width | Yes |
| Yes | Landing Cross Slope (%) | 1.4 | | DWS Offset Type | Single |
| Yes | Overall Surface Condition | Acceptable | | | |
