Access Compliance Report Public Rights-of-Way (Curb Ramps)

Main Street: HICKORY_BRANCH_RD **Cross Street: HICKORY BRANCH RD** Location: SE ADA ID: RPAT211008142202 Ramp Type: Type 4 - Parallel **Initial Pass/Fail: Pass Overall Compliance: No Severity Score:**

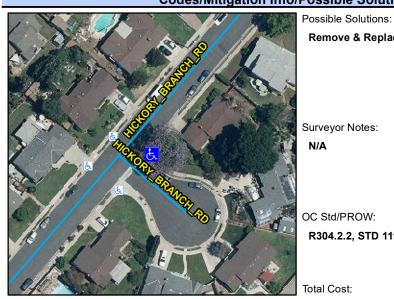
D		Marked Crosswalk 1 Width (in)	N/A		Marked	Crosswalk 2 Width (in)	N/A	
οl	N/A	Ramp Inside Crosswalk 1	N/A	N/A	Ramp Ir	nside Crosswalk 2	N/A	
D		Crossing 1 Slope (%)	6		Crossing	g 2 Slope (%)	1.6	
ol		Crossing 1 Cross Slope (%)	0.9		Crossing	g 2 Cross Slope (%)	0.5	
	Yes	Gutter Ponding	No	No	Curb Slo	ope	15.2	
	Yes	Gutter Lip Height (in)	0		Road R	un Slope (%)	1.5	
	Yes	Gutter Run Slope (%)	3.6		Road Ci	ross Slope (%)	2.6	
<u>а</u>	Yes	Gutter Cross Slope (%)	0.2	Yes	Perpend	licular Joint Present	Yes	
0	Yes	Overall Surface Condition Accep	otable					
		Cross Gutter Present?	Yes		Spandr	el Present?	Yes	
A		Replace Cross Gutter?	No		Replace	e Spandrel?	No

Remove & Replace Curb Slope.

R304.2.2, STD 1115
