# Access Compliance Report Public Rights-of-Way (Curb Ramps)

| Main Street: BLUEBERRY_WAY | | Cross Street: BRITTANY_WOODS_DR | | Location: | SW |
| ADA ID: RPAT211008145918 | Ramp Type: Type 4 - Parallel | Initial Pass/Fail: Fail | Overall Compliance: No | Severity Score: | 16 |

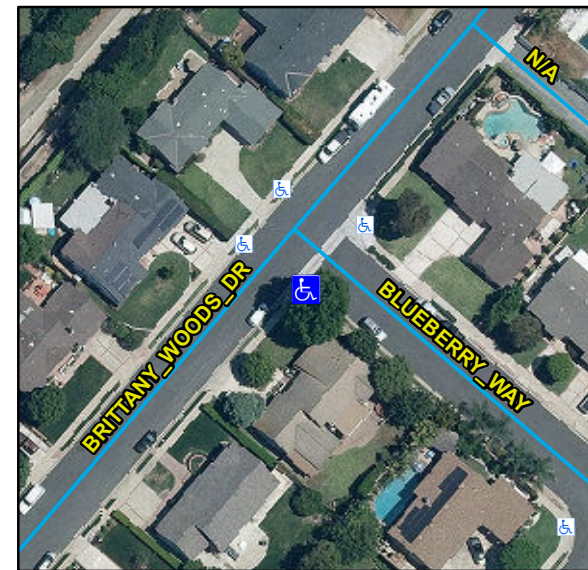
| Compliance | Description | Data | Compliance | Description | Data |
|---|---|---|---|---|---|
| No | Ramp Run Slope LT (%) | 10.3 | No | Ramp Run Slope RT (%) | 9.5 |
| No | Ramp Cross Slope LT (%) | 3.5 | No | Ramp Cross Slope RT (%) | 4.3 |

**Remove & Replace Curb Ramp With Two New Directional Ramps or Equivalent.**

**R304.3.2, R304.5.3, STD 1115**

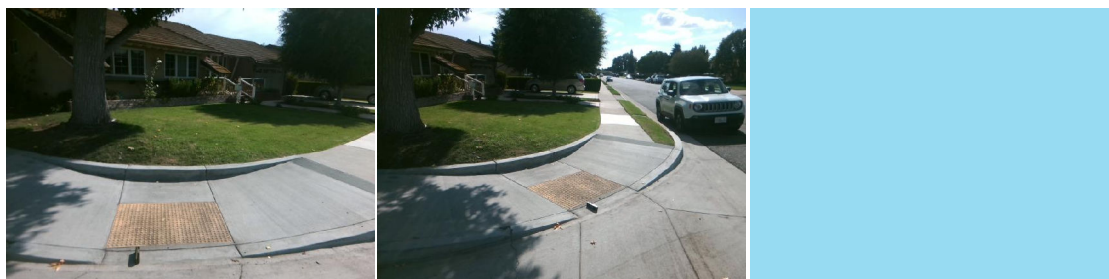
| Compliance | Description | Data | Compliance | Description | Data |
|---|---|---|---|---|---|
| Yes | Obstructions Present? | No | N/A | Utilities Present? | No |
