# Access Compliance Report Public Rights-of-Way (Curb Ramps)

Main Street: WOODLAWN\_AVE Cross Street: SE\_SKYLINE\_DR Location: SE

ADA ID: RPAT211012131951 Ramp Type: Type 6 - Directional 1 Initial Pass/Fail: Pass Overall Compliance: No Severity Score: 9

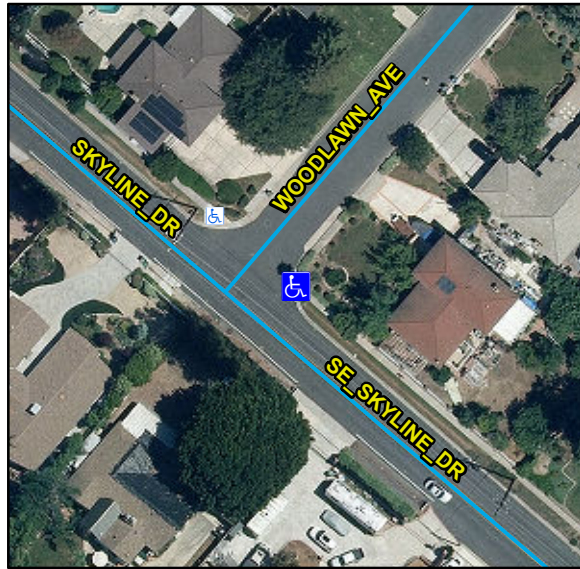
| Compliance | Description | Data | Compliance | Description | Data |
|---|---|---|---|---|---|
| No | Grade Break | No | N/A | Flare Type RT | |
| No | Landing Length (in) | 42 | Yes | DWS Length (in) | 54 |
| No | Landing Cross Slope (%) | 2.2 | Yes | DWS Left Offset (in) | 1 |
| Yes | Gutter Ponding | No | No | Curb Slope | 14.3 |
| No | Gutter Run Slope (%) | 6.5 | | Road Cross Slope (%) | N/A |

Remove & Replace Entire Ramp. Remove & Replace Gutter.
