# Access Compliance Report Public Rights-of-Way (Curb Ramps)

| Main Street: EVENINGSIDE_DR | | Cross Street: RANCHWOOD_RD | | Location: | NE |
| ADA ID: RPAT211013145802 | Ramp Type: Type 4 - Parallel | Initial Pass/Fail: Pass | Overall Compliance: No | Severity Score: | 4 |

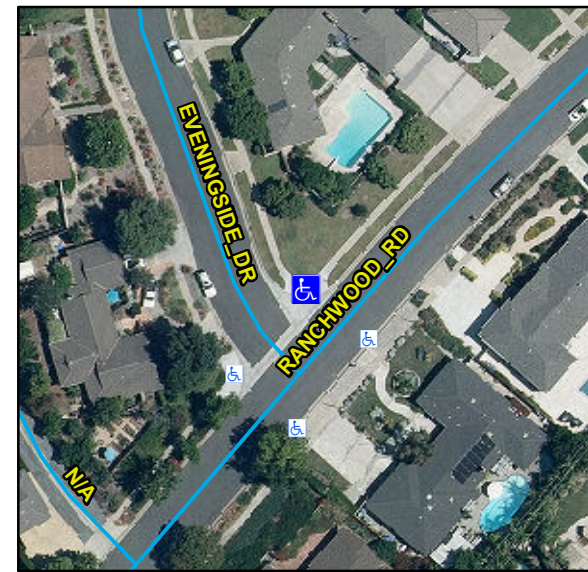
R304.2.1, STD 1115

| Compliance | Description | Data | Compliance | Description | Data |
|---|---|---|---|---|---|
| N/A | Landing Length (in) | 44 | Yes | DWS Contrast | Yes |

Possible Solutions:

Remove & Replace Landing.
