# Access Compliance Report Public Rights-of-Way (Curb Ramps)

Main Street: TRIUMPHAL\_WAY Cross Street: FORUM\_WAY Location: SW

ADA ID: RPAT211015141957 Ramp Type: Type 1 - Perpendicular Diagonal Initial Pass/Fail: Pass Overall Compliance: No Severity Score: 22

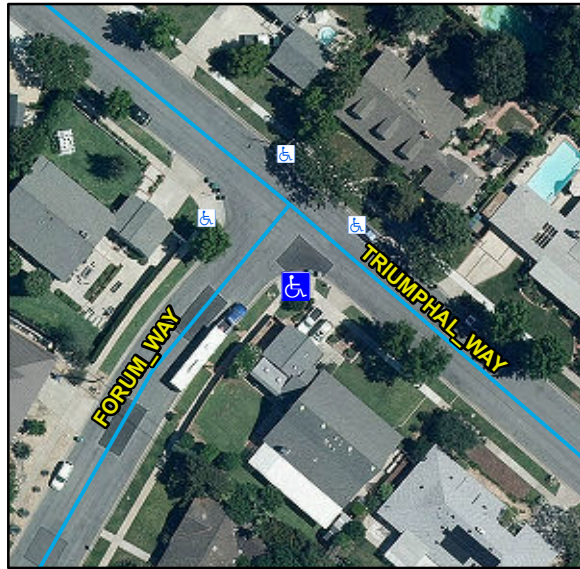
| Compliance | Description | Data | Compliance | Description | Data |
|---|---|---|---|---|---|
| No | Ramp Cross Slope (%) | 2.3 | N/A | Flare Traversable LT | No |
| No | Landing Width (in) | N/A | N/A | Flare Slope RT (%) | 2.7 |
| No | Landing Run Slope (%) | N/A | N/A | Flare Traversable RT | No |
| No | Landing Cross Slope (%) | N/A | No | DWS Provided | No |

Remove & Replace Curb Ramp With Two New Directional Ramps or Equivalent.

R204.3, R304.5.3, R304.2.1, R304.2.2-Perp, R304.3.2-Para, R305, STD 1115
