# Access Compliance Report Public Rights-of-Way (Curb Ramps)

Main Street: **EMPEROR\_DR** Cross Street: **TEA\_HOUSE\_ST** Location: **S**

ADA ID: **RPAT211018141009** Ramp Type: **Type 1 - Perpendicular Diagonal** Initial Pass/Fail: **Pass** Overall Compliance: **Yes** Severity Score: **0**

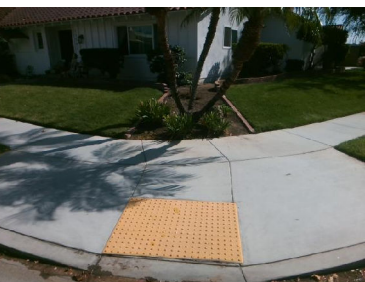
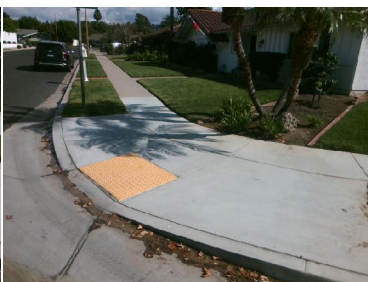
| Compliance | Description | Data | Compliance | Description | Data |
|---|---|---|---|---|---|
| <b>Yes</b> | Overall Surface Condition: <b>Acceptable</b> | | <b>Yes</b> | Perp Joint Present | <b>Yes</b> |
