# Access Compliance Report Public Rights-of-Way (Curb Ramps)

Main Street: LAURIE\_LN Cross Street: PROSPECT\_AVE Location: SW

ADA ID: RPAT211018144936 Ramp Type: Type 7 - Directional 2 Initial Pass/Fail: Fail Overall Compliance: No Severity Score: 30

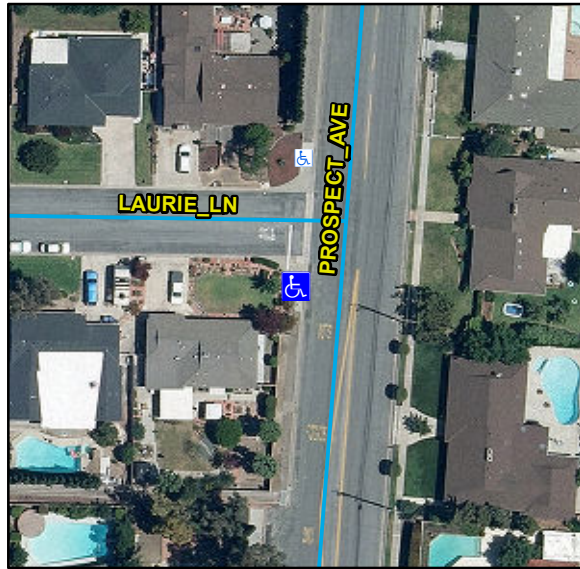
| Compliance | Description | Data | Compliance | Description | Data |
|---|---|---|---|---|---|
| No | Ramp Cross Slope (%) | 9 | N/A | Flare Traversable LT | N/A |

Remove & Replace Entire Ramp.

R304.5.3, STD 1115

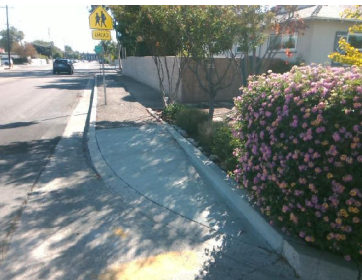
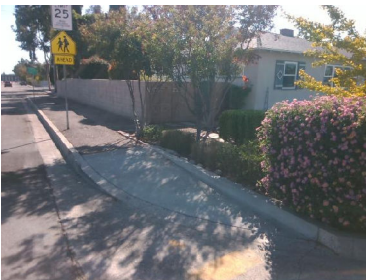
| Compliance | Description | Data | Compliance | Description | Data |
|---|---|---|---|---|---|
| Yes | Overall Surface Condition | Acceptable | Yes | Perp Joint Present | Yes |
