# Access Compliance Report Public Rights-of-Way (Curb Ramps)

Main Street: SUSSEX\_PL Cross Street: DODGE\_AVE Location: SW

ADA ID: RPAT211019134240 Ramp Type: Type 6 - Directional 1 Initial Pass/Fail: Pass Overall Compliance: No Severity Score: 2

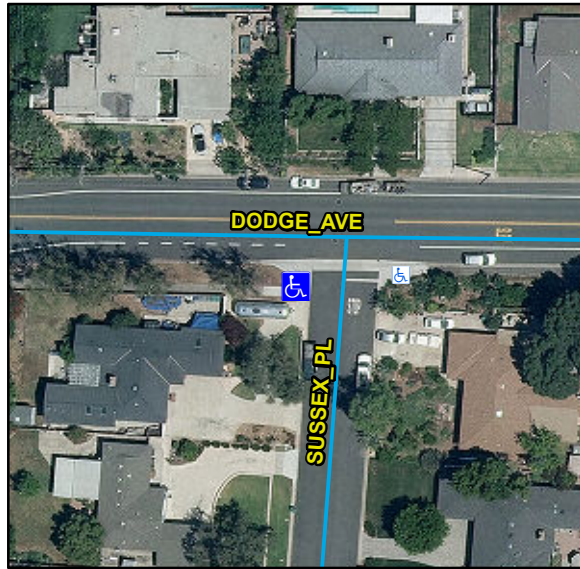
| Compliance | Description | Data | Compliance | Description | Data |
|---|---|---|---|---|---|
| No | Ramp Cross Slope (%) | 2.8 | N/A | Flare Traversable LT | N/A |
| No | Grade Break Slope (%) | 6.6 | | | Curbed2 |
| No | Grade Break Cross Slope (%) | 2.6 | N/A | Flare Slope RT (%) | N/A |
| No | Gutter Cross Slope (%) | 2.4 | | Parallel Ramp Side | N/A |

Remove & Replace Entire Ramp. Remove & Replace Gutter.
