# Access Compliance Report Public Rights-of-Way (Curb Ramps)

Main Street: N/A Cross Street: PROSPECT\_ST Location: SE

ADA ID: RPAT211022105723 Ramp Type: Type 6 - Directional 1 Initial Pass/Fail: Pass Overall Compliance: No Severity Score: 4

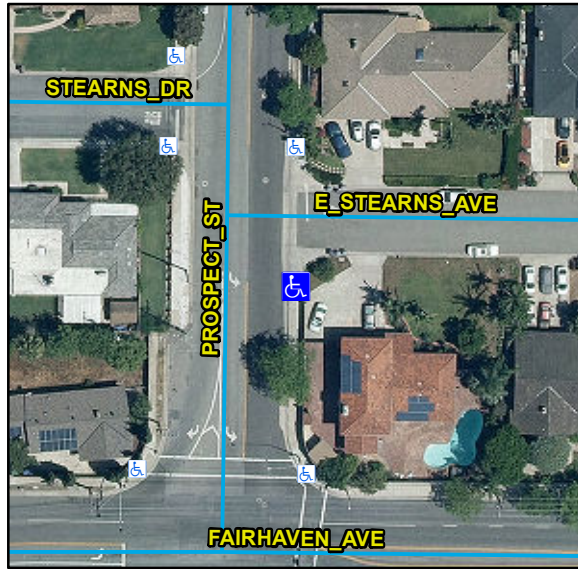
| Compliance | Description | Data | Compliance | Description | Data |
|---|---|---|---|---|---|
| No | Landing Length (in) | 42 | Yes | DWS Length (in) | 36 |
| No | Landing Cross Slope (%) | 2.1 | Yes | DWS Left Offset (in) | 60 |
| No | Gutter Cross Slope (%) | 5 | | Parallel Ramp Side | Left |

Remove & Replace Entire Ramp. Remove & Replace Gutter.

R304.2.1, R304.5.3, R304.2.3, STD 1115
