# Access Compliance Report Public Rights-of-Way (Curb Ramps)

Main Street: N/A Cross Street: PROSPECT\_ST Location: NE

ADA ID: RPAT211022110554 Ramp Type: Type 6 - Directional 1 Initial Pass/Fail: Pass Overall Compliance: No Severity Score: 0

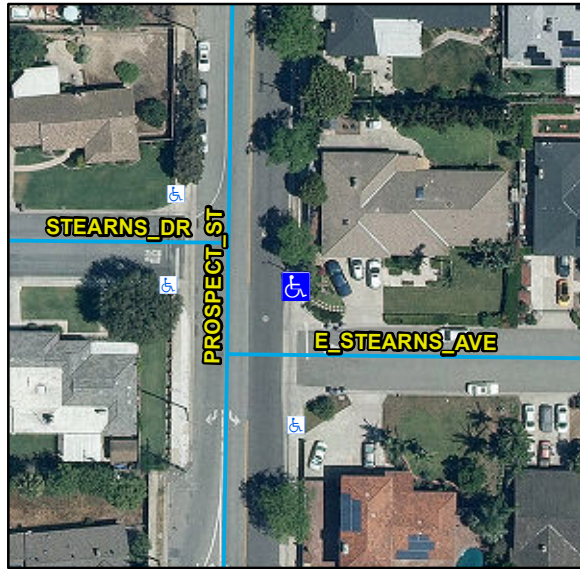
| Compliance | Description | Data | Compliance | Description | Data |
|---|---|---|---|---|---|
| N/A | Ramp Length (in) | 155 | No | Flare Type LT | |
| No | Landing Run Slope (%) | 2.4 | | DWS Offset Type | Multiple |
| No | Landing Cross Slope (%) | 3 | Yes | DWS Left Offset (in) | 0 |

Remove & Replace Entire Ramp.

R304.2.2-Perp, R304.3.2-Para, R304.5.3, R304.2.3, STD 1115
