# Access Compliance Report Public Rights-of-Way (Curb Ramps)

Main Street: LASSEN\_DR Cross Street: ESPLANADE\_AVE Location: SW

ADA ID: RPAT211026135644 Ramp Type: Type 6 - Directional 1 Initial Pass/Fail: Pass Overall Compliance: No Severity Score: 6

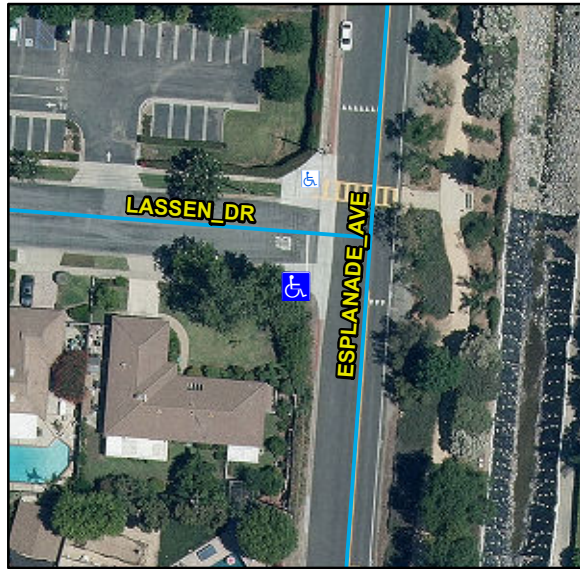
| Compliance | Description | Data | Compliance | Description | Data |
|---|---|---|---|---|---|
| No | Landing Length (in) | 25 | Yes | DWS Length (in) | 36 |
| No | Landing Run Slope (%) | 3.5 | | DWS Offset Type | Multiple |
| No | Landing Cross Slope (%) | 2.5 | Yes | DWS Left Offset (in) | 24 |
| No | Gutter Cross Slope (%) | 2.5 | | Parallel Ramp Side | N/A |

Remove & Replace Entire Ramp. Remove & Replace Gutter.
