# Access Compliance Report Public Rights-of-Way (Curb Ramps)

Main Street: HEWES\_ST Cross Street: BOND\_AVE Location: NE

ADA ID: RPAT211027140636 Ramp Type: Type 1 - Perpendicular Diagonal Initial Pass/Fail: Pass Overall Compliance: No Severity Score: 0

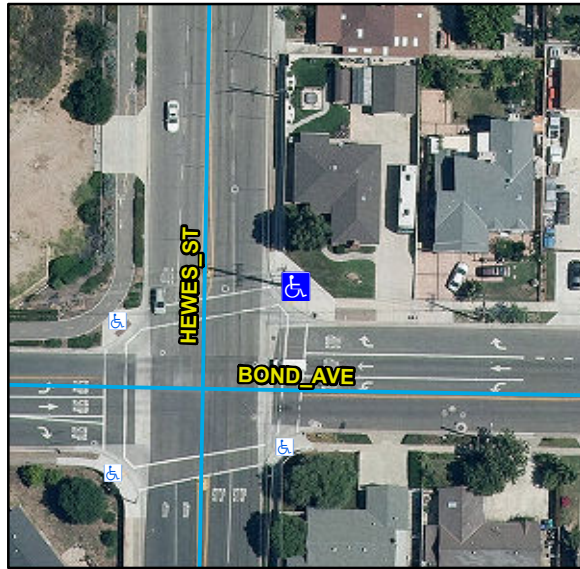
| Compliance | Description | Data | Compliance | Description | Data |
|---|---|---|---|---|---|
| Yes | Gutter Ponding | No | No | Curb Slope | 11.4 |

Remove & Replace Curb Slope.

R304.2.2, STD 1115

Total Cost: \$ 252
