# Access Compliance Report Public Rights-of-Way (Curb Ramps)

| Main Street: SMOKE_TREE_DR | | Cross Street: CAMERONS_WAY | | Location: | E |
| ADA ID: RPAT211102154447 | Ramp Type: Type 4 - Parallel | Initial Pass/Fail: Fail | Overall Compliance: No | Severity Score: | 16 |

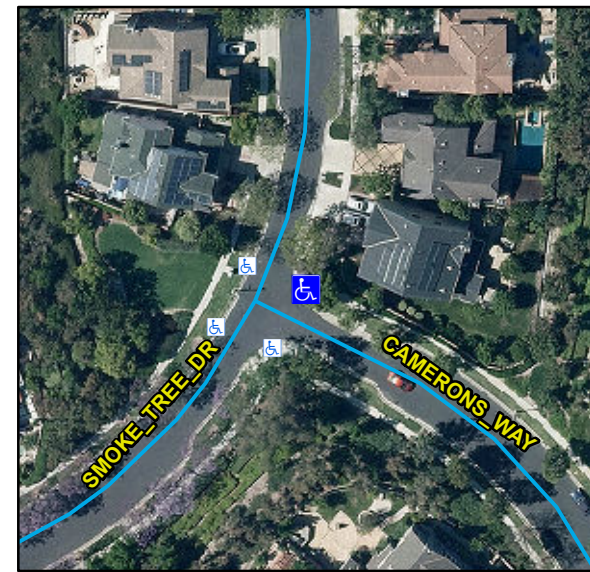
| Compliance | Description | Data | Compliance | Description | Data |
|---|---|---|---|---|---|
| Yes | Ramp Run Slope LT (%) | 4.4 | No | Ramp Run Slope RT (%) | 8.4 |
| Yes | Ramp Cross Slope LT (%) | 1.6 | No | Ramp Cross Slope RT (%) | 4.2 |

**Remove & Replace Curb Ramp With Two New Directional Ramps or Equivalent.**

**R204.3, R304.3.2, R304.5.3, STD 1115**
