# Access Compliance Report Public Rights-of-Way (Curb Ramps)

| Main Street: DOWNING_ST | | Cross Street: CHARDONNAY_DR | | Location: | NE |
| ADA ID: RPAT211103105522 | Ramp Type: Type 4 - Parallel | Initial Pass/Fail: Pass | Overall Compliance: No | Severity Score: | 10 |

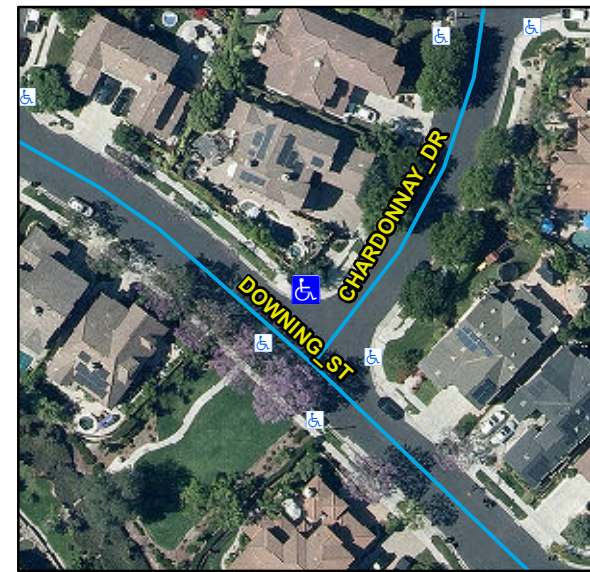
| Compliance | Description | Data | Compliance | Description | Data |
|---|---|---|---|---|---|
| N/A | Landing Present | Yes | No | DWS Provided | No |
| Yes | Gutter Cross Slope (%) | 2 | No | Perpendicular Joint Present | No |

**Remove & Replace Curb Ramp With Two New Directional Ramps or Equivalent.**

**R204.3, R305, STD 1115**

Total Cost: \$ 4000

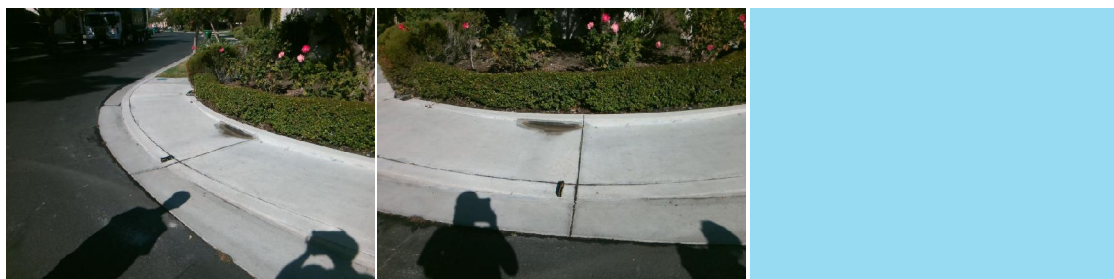
| Compliance | Description | Data | Compliance | Description | Data |
| N/A | Ramp Length LT (in) | 112 | N/A | Ramp Length RT (in) | 109 |
| Yes | Ramp Width LT (in) | 54 | Yes | Ramp Width RT (in) | 54 |
| Yes | Ramp Run Slope LT (%) | 1.4 | Yes | Ramp Run Slope RT (%) | 7 |
