# Access Compliance Report Public Rights-of-Way (Curb Ramps)

| Main Street: NEWBURY WAY | | Cross Street: FRANKLIN WAY | | Location: | SW |
| ADA ID: RPAT211104134957 | Ramp Type: Type 4 - Parallel | Initial Pass/Fail: Fail | Overall Compliance: No | Severity Score: | 15 |

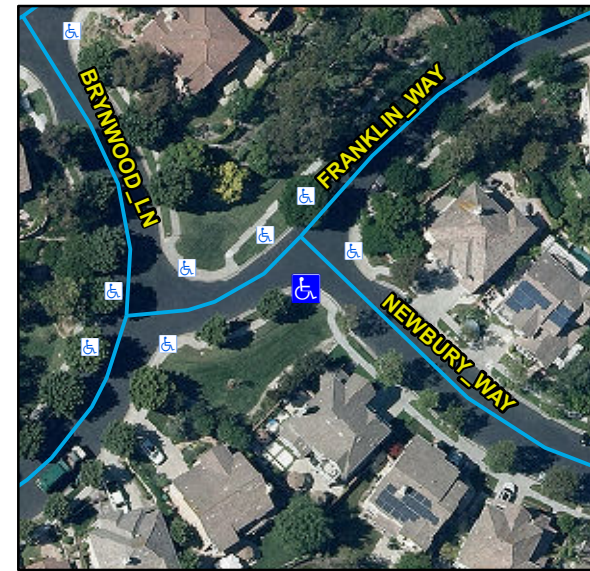
| Compliance | Description | Data | Compliance | Description | Data |
|---|---|---|---|---|---|
| Yes | Ramp Run Slope LT (%) | 0.3 | No | Ramp Run Slope RT (%) | 10.7 |
| N/A | Gutter Cross Slope (%) | N/A | No | Perpendicular Joint Present | No |

**Remove & Replace Curb Ramp With Two New Directional Ramps or Equivalent.**

**R204.3, R304.3.2, STD 1115**
