# Access Compliance Report Public Rights-of-Way (Curb Ramps)

Main Street: WOODLAWN\_AVE Cross Street: TIFFANY\_PL Location: NW

ADA ID: RPAT211110120347 Ramp Type: Type 1 - Perpendicular Diagonal Initial Pass/Fail: Pass Overall Compliance: No Severity Score: 0

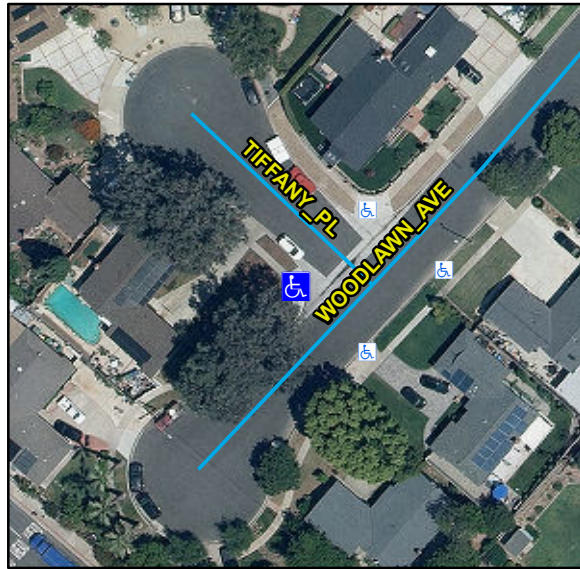
| Compliance | Description | Data | Compliance | Description | Data |
|---|---|---|---|---|---|
| Yes | Gutter Ponding | No | No | Curb Slope | 7 |

Remove & Replace Curb Ramp With Two New Directional Ramps or Equivalent.

R304.2.2, R304.2.1, STD 1115
