# Access Compliance Report Public Rights-of-Way (Curb Ramps)

Main Street: ENTYRE\_AVE Cross Street: MCCORMACK\_LN Location: SE

ADA ID: RPAT211112112451 Ramp Type: Type 1 - Perpendicular Diagonal Initial Pass/Fail: Pass Overall Compliance: No Severity Score: 6

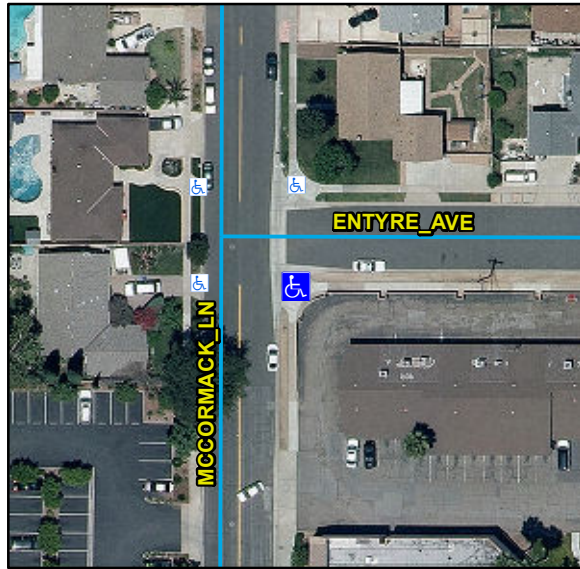
| Compliance | Description | Data | Compliance | Description | Data |
|---|---|---|---|---|---|
| No | Landing Run Slope (%) | 4.6 | N/A | Flare Traversable RT | No |
| Yes | Gutter Ponding | No | No | Curb Slope | 14.3 |
| No | Gutter Run Slope (%) | 5.9 | | Road Cross Slope (%) | 3.2 |

Remove & Replace Curb Ramp With Two New Directional Ramps or Equivalent. Remove & Replace Gutter.
