# Access Compliance Report Public Rights-of-Way (Curb Ramps)

Main Street: **HAMER\_DR** Cross Street: **E\_YORBA\_LINDA\_BLVD** Location: **NE**

ADA ID: **RPAT211112144146** Ramp Type: **Type 1 - Perpendicular Diagonal** Initial Pass/Fail: **Pass** Overall Compliance: **No** Severity Score: **5**

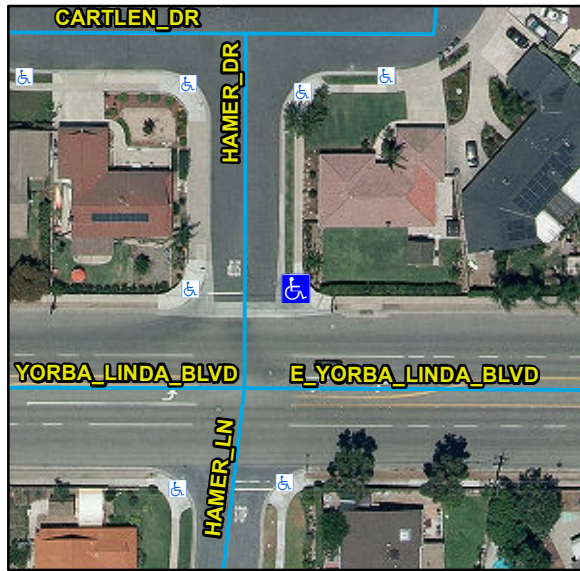
| Compliance | Description | Data | Compliance | Description | Data |
|---|---|---|---|---|---|
| Yes | Gutter Ponding | No | No | Curb Slope | 10.9 |
| No | Gutter Run Slope (%) | 6.3 | | Road Cross Slope (%) | 1.2 |

**Remove & Replace Curb Ramp With Two New Directional Ramps or Equivalent. Remove & Replace Gutter.**
