# Access Compliance Report Public Rights-of-Way (Curb Ramps)

| Main Street: COLONY_ST | | Cross Street: STONYBROOK_DR | | Location: | NE |
| ADA ID: RPAT211117113549 | Ramp Type: Type 4 - Parallel | Initial Pass/Fail: Pass | Overall Compliance: Yes | Severity Score: | 0 |

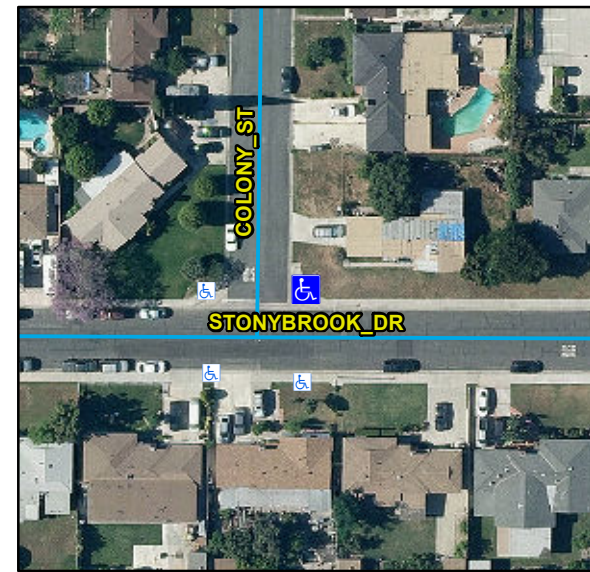
Possible Solutions:

N/A

Surveyor Notes:

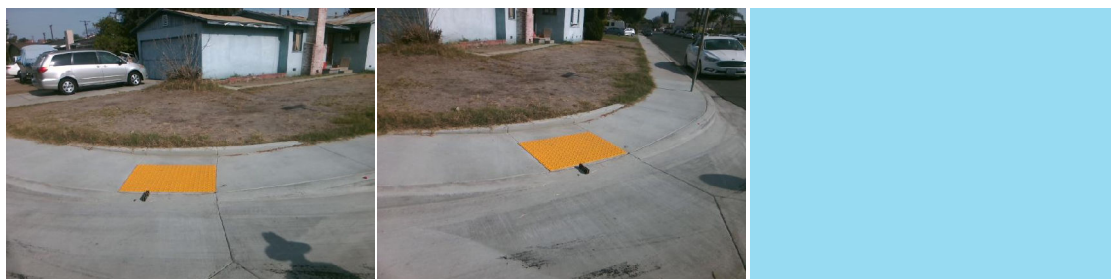
| Compliance | Description | Data | Compliance | Description | Data |
|---|---|---|---|---|---|
| N/A | Ramp Length LT (in) | 71 | N/A | Ramp Length RT (in) | 75 |
| Yes | Ramp Width LT (in) | 54 | Yes | Ramp Width RT (in) | 54 |
| Yes | Ramp Run Slope LT (%) | 6.1 | Yes | Ramp Run Slope RT (%) | 6.8 |
| Yes | Ramp Cross Slope LT (%) | 1.1 | Yes | Ramp Cross Slope RT (%) | 0.4 |
| Yes | Landing Width (in) | 48 | Yes | DWS Length (in) | 36 |
| Yes | Landing Run Slope (%) | 1.2 | Yes | DWS Full Width | Yes |
| Yes | Landing Cross Slope (%) | 0.1 | | DWS Offset Type | Single |
| Yes | Gutter Ponding | No | Yes | Curb Slope | 7.3 |
| Yes | Gutter Lip Height (in) | 0 | | Road Run Slope (%) | 0.4 |
| Yes | Gutter Run Slope (%) | 4.6 | | Road Cross Slope (%) | 3.7 |
| Yes | Gutter Cross Slope (%) | 1.5 | Yes | Perpendicular Joint Present | Yes |
| Yes | Overall Surface Condition | Acceptable | | | |
