# Access Compliance Report Public Rights-of-Way (Curb Ramps)

Main Street: STONYBROOK\_DR Cross Street: ROSEBAY\_ST Location: NW

ADA ID: RPAT211117120443 Ramp Type: Type 4 - Parallel Initial Pass/Fail: Pass Overall Compliance: Yes Severity Score: 0

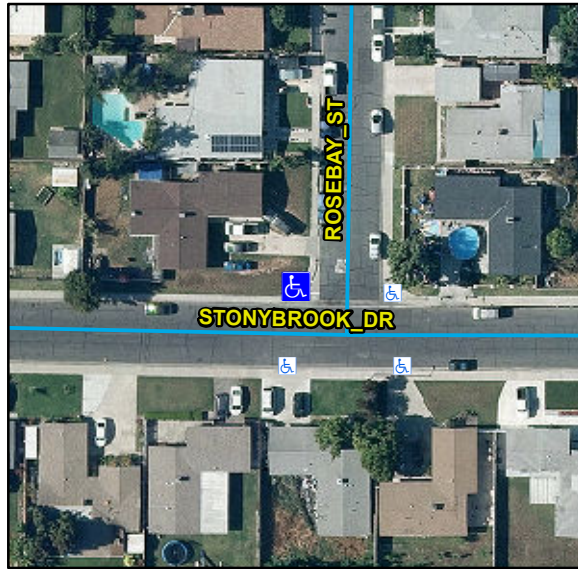
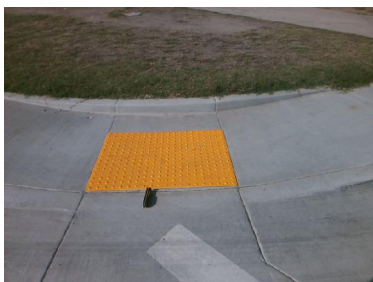
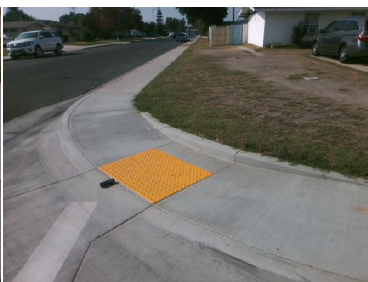
| Compliance | Description | Data | Compliance | Description | Data |
|---|---|---|---|---|---|
| N/A | Ramp Length LT (in) | 75 | N/A | Ramp Length RT (in) | 77 |
| Yes | Ramp Width LT (in) | 53 | Yes | Ramp Width RT (in) | 54 |
| Yes | Ramp Run Slope LT (%) | 6.2 | Yes | Ramp Run Slope RT (%) | 7.5 |
| Yes | Ramp Cross Slope LT (%) | 0.7 | Yes | Ramp Cross Slope RT (%) | 0.9 |
| Yes | Landing Width (in) | 48 | Yes | DWS Length (in) | 36 |
| Yes | Landing Run Slope (%) | 0.4 | Yes | DWS Full Width | Yes |
| Yes | Landing Cross Slope (%) | 0.6 | | DWS Offset Type | Single |
| Yes | Overall Surface Condition | Acceptable | | | |

N/A
