# Access Compliance Report Public Rights-of-Way (Curb Ramps)

| Main Street: STONYBROOK_DR | | Cross Street: PARADE_ST | | Location: | NW |
| ADA ID: RPAT211117121623 | Ramp Type: Type 4 - Parallel | Initial Pass/Fail: Pass | Overall Compliance: No | Severity Score: | 2 |

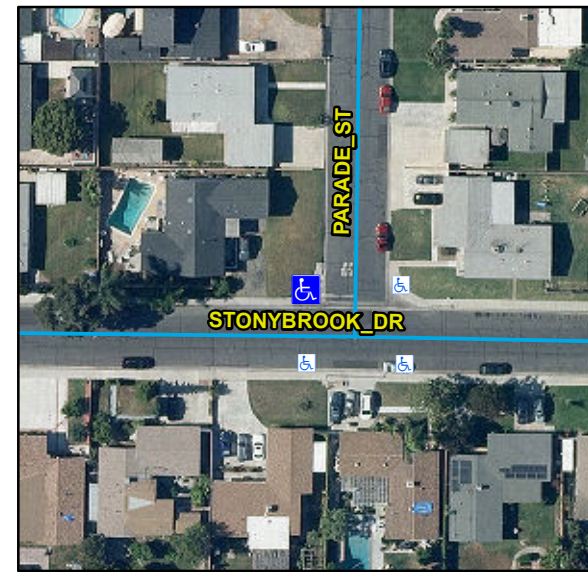
| Compliance | Description | Data | Compliance | Description | Data |
|---|---|---|---|---|---|
| No | Gutter Cross Slope (%) | 2.4 | Yes | Perpendicular Joint Present | Yes |

Possible Solutions:

Remove & Replace Gutter.

R304.5.3, STD 1115
