# Access Compliance Report Public Rights-of-Way (Curb Ramps)

Main Street: HARVEST\_ST Cross Street: STONYBROOK\_DR Location: NE

ADA ID: RPAT211117122144 Ramp Type: Type 4 - Parallel Initial Pass/Fail: Pass Overall Compliance: No Severity Score: 0

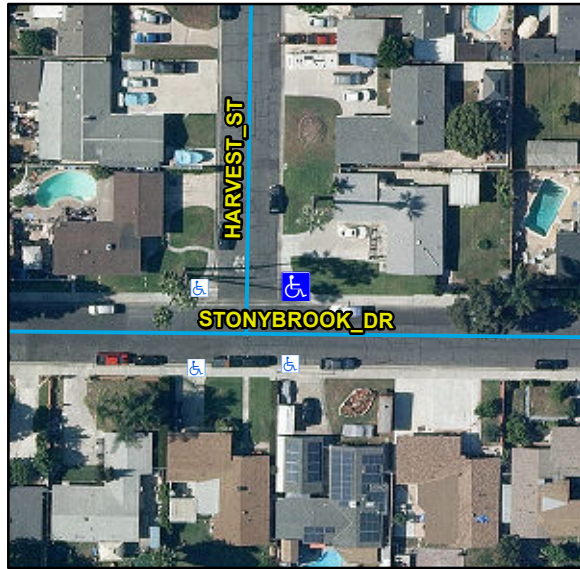
R304.5.3, STD 1115

| Compliance | Description | Data | Compliance | Description | Data |
|---|---|---|---|---|---|
| No | Gutter Cross Slope (%) | 3.3 | Yes | Perpendicular Joint Present | Yes |

Remove & Replace Gutter.
