# Access Compliance Report Public Rights-of-Way (Curb Ramps)

| Main Street: CLEARBROOK_LN | | Cross Street: ROSEBAY_ST | | Location: | SE |
| ADA ID: RPAT211117130243 | Ramp Type: Type 4 - Parallel | Initial Pass/Fail: Pass | Overall Compliance: Yes | Severity Score: | 0 |

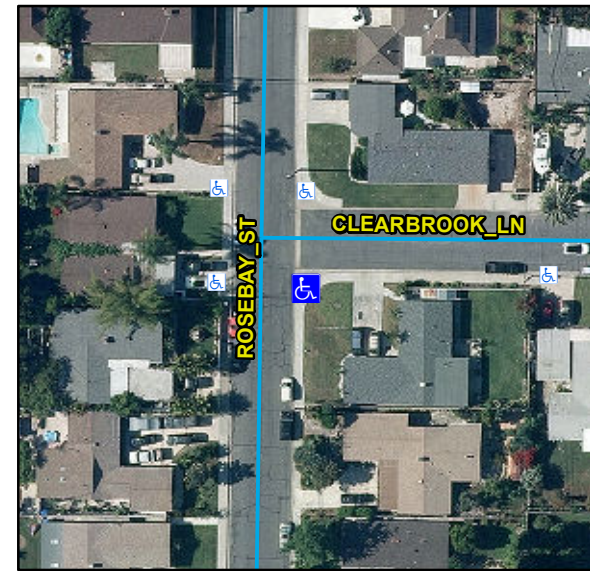
| Compliance | Description | Data | Compliance | Description | Data |
|---|---|---|---|---|---|
| N/A | Ramp Length LT (in) | 82 | N/A | Ramp Length RT (in) | 74 |
| Yes | Ramp Width LT (in) | 54 | Yes | Ramp Width RT (in) | 54 |
| Yes | Ramp Run Slope LT (%) | 7.1 | Yes | Ramp Run Slope RT (%) | 5.8 |
| Yes | Ramp Cross Slope LT (%) | 1.3 | Yes | Ramp Cross Slope RT (%) | 0.5 |
| N/A | Landing Present | Yes | Yes | DWS Provided | Yes |
| N/A | Landing Length (in) | 54 | Yes | DWS Contrast | Yes |
| Yes | Landing Width (in) | 48 | Yes | DWS Length (in) | 36 |
| Yes | Landing Run Slope (%) | 1.5 | Yes | DWS Full Width | Yes |
| Yes | Landing Cross Slope (%) | 0.4 | | DWS Offset Type | Single |

Possible Solutions:

N/A
