# Access Compliance Report Public Rights-of-Way (Curb Ramps)

Main Street: BIENVILLE\_AVE Cross Street: GRAVIER\_ST Location: SE

ADA ID: RPAT211118104410 Ramp Type: Type 4 - Parallel Initial Pass/Fail: Pass Overall Compliance: Yes Severity Score: 0

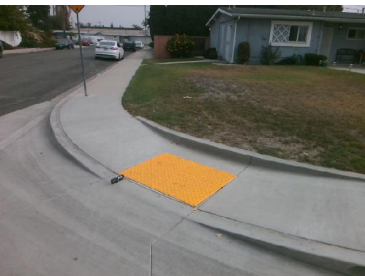
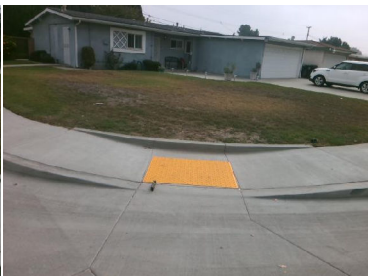
| Compliance | Description | Data | Compliance | Description | Data |
|---|---|---|---|---|---|
| Yes | Overall Surface Condition | Acceptable | | | |
