# Access Compliance Report Public Rights-of-Way (Curb Ramps)

Main Street: BIENVILLE\_AVE Cross Street: GRAVIER\_ST Location: NW

ADA ID: RPAT211118112212 Ramp Type: Type 4 - Parallel Initial Pass/Fail: Pass Overall Compliance: Yes Severity Score: 0

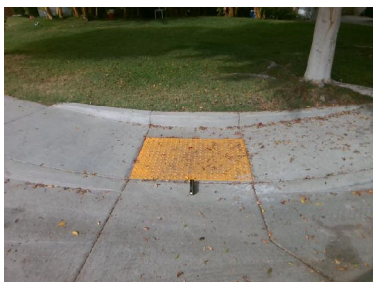
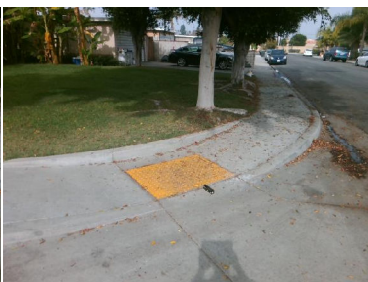
| Compliance | Description | Data | Compliance | Description | Data |
|---|---|---|---|---|---|
| Yes | Overall Surface Condition | Acceptable | | | |
