# Access Compliance Report

## Public Rights-of-Way

### (Curb Ramps)

| Main Street: CHANTICLEER_RD | | Cross Street: PERDIDO_ST | | Location: | NW |

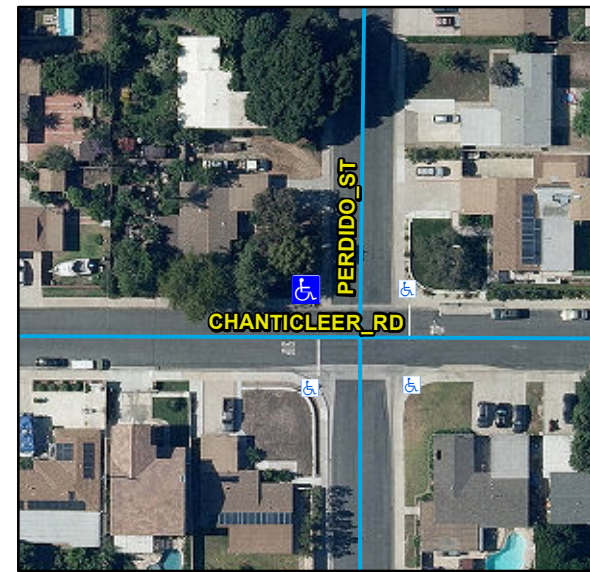
| ADA ID: RPAT211119103138 | Ramp Type: Type 4 - Parallel | Initial Pass/Fail: Pass | Overall Compliance: Yes | Severity Score: | 0 |

Possible Solutions:

N/A

Surveyor Notes:

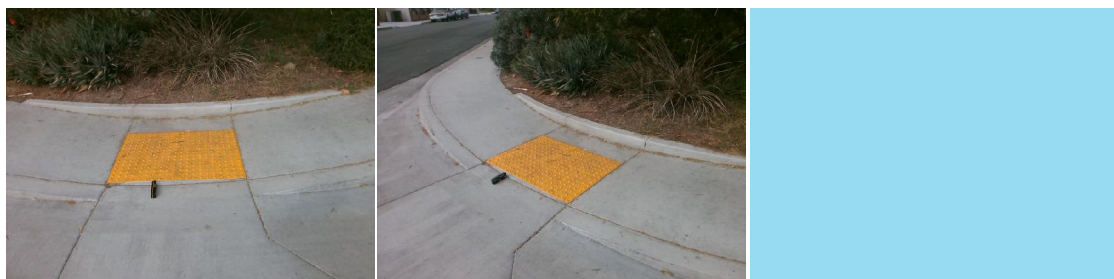
| Compliance | Description | Data | Compliance | Description | Data |
|---|---|---|---|---|---|
| N/A | Ramp Length LT (in) | 77 | N/A | Ramp Length RT (in) | 77 |
| Yes | Ramp Width LT (in) | 55 | Yes | Ramp Width RT (in) | 54 |
| Yes | Ramp Run Slope LT (%) | 5 | Yes | Ramp Run Slope RT (%) | 6.1 |
| Yes | Ramp Cross Slope LT (%) | 0.5 | Yes | Ramp Cross Slope RT (%) | 0.4 |
| N/A | Landing Present | Yes | Yes | DWS Provided | Yes |
| Yes | Landing Width (in) | 48 | Yes | DWS Length (in) | 36 |
| Yes | Gutter Ponding | No | Yes | Curb Slope | 3.5 |
| Yes | Overall Surface Condition | Acceptable | | | |
