# Access Compliance Report Public Rights-of-Way (Curb Ramps)

Main Street: CERRITOS\_AVE Cross Street: HARCOURT\_AVE Location: SE

ADA ID: RPAT211122122145 Ramp Type: Type 4 - Parallel Initial Pass/Fail: Pass Overall Compliance: Yes Severity Score: 2

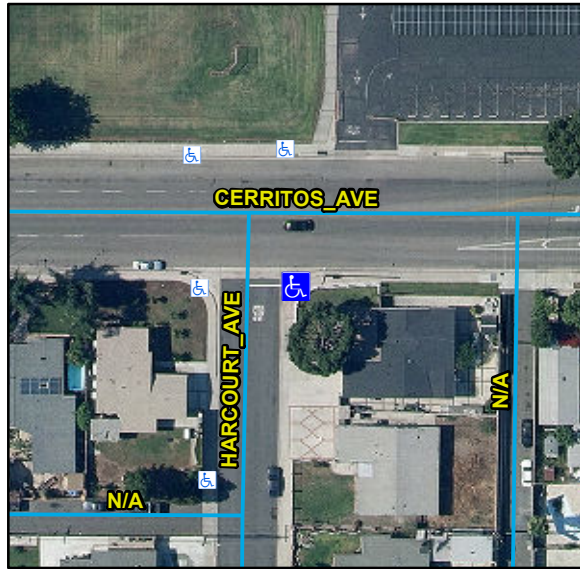
| Compliance | Description | Data | Compliance | Description | Data |
|---|---|---|---|---|---|
| Yes | Overall Surface Condition | Acceptable | | | |

N/A
