# Access Compliance Report Public Rights-of-Way (Curb Ramps)

| Main Street: N/A | | Cross Street: HARCOURT_AVE | | Location: | NW |
| ADA ID: RPAT211122122921 | Ramp Type:Type 1 - Perpendicular | Initial Pass/Fail: Pass | Overall Compliance: No | Severity Score: | 5 |

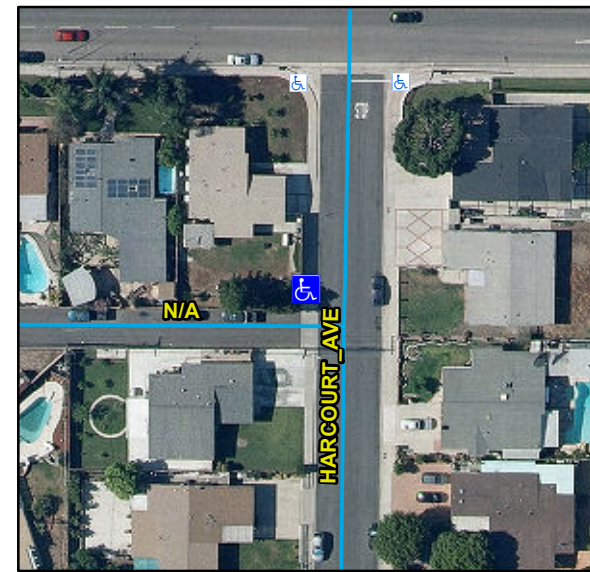
**R304.2.2, R305.1.4, R304.5.3, STD 1115**

| Compliance | Description | Data | Compliance | Description | Data |
|---|---|---|---|---|---|
| N/A | Landing Shared | No | No | DWS Full Width | No |
| Yes | Gutter Ponding | No | No | Curb Slope | 7.8 |
| No | Gutter Cross Slope (%) | 7.1 | | | |

**Remove & Replace Entire Ramp. Remove & Replace Gutter.**
