# Access Compliance Report Public Rights-of-Way (Curb Ramps)

| Main Street: HARCOURT_AVE | | Cross Street: PACIFIC_PL | | Location: | SW |
| ADA ID: RPAT211123142346 | Ramp Type: Type 4 - Parallel | Initial Pass/Fail: Pass | Overall Compliance: No | Severity Score: | 5 |

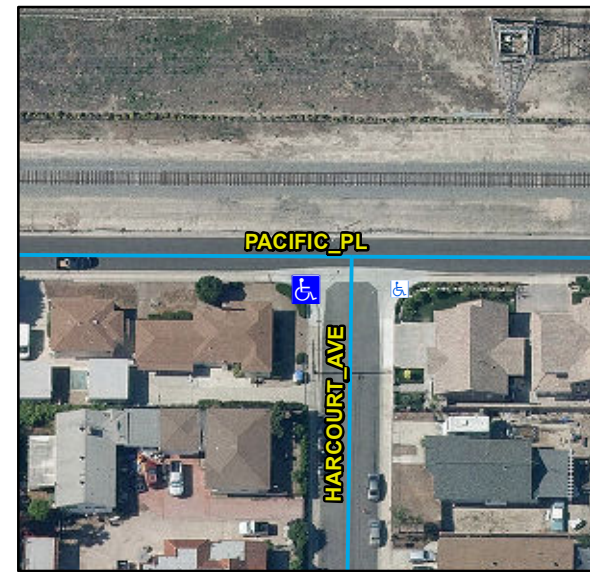
| Compliance | Description | Data | Compliance | Description | Data |
|---|---|---|---|---|---|
| No | Gutter Run Slope (%) | 7.1 | | Road Cross Slope (%) | 0.7 |

Possible Solutions:

Remove & Replace Gutter.

R304.5.4, STD 1115

Total Cost: \$ 252
