# Access Compliance Report Public Rights-of-Way (Curb Ramps)

| Main Street: SANDY_DR | | Cross Street: FILLMORE_DR | | Location: | NW |
| ADA ID: RPAT211124105001 | Ramp Type: Type 4 - Parallel | Initial Pass/Fail: Pass | Overall Compliance: No | Severity Score: | 5 |

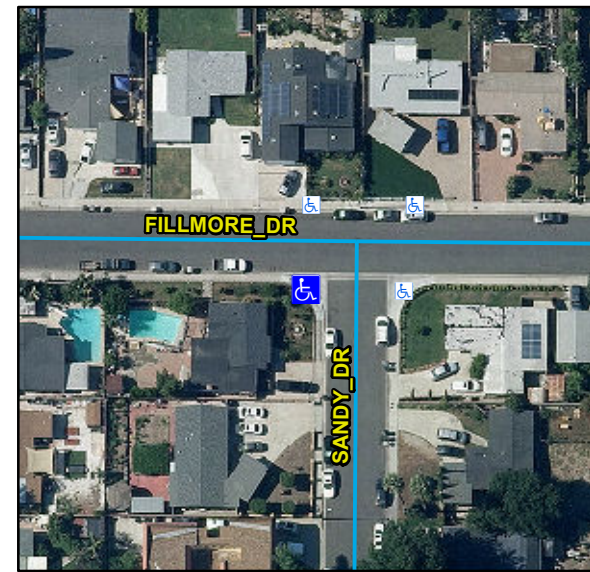
| Compliance | Description | Data | Compliance | Description | Data |
|---|---|---|---|---|---|
| No | Gutter Ponding | Yes | Yes | Curb Slope | 6.8 |
| No | Gutter Run Slope (%) | 5.9 | | Road Cross Slope (%) | 0.3 |

Possible Solutions:

Remove & Replace Gutter.

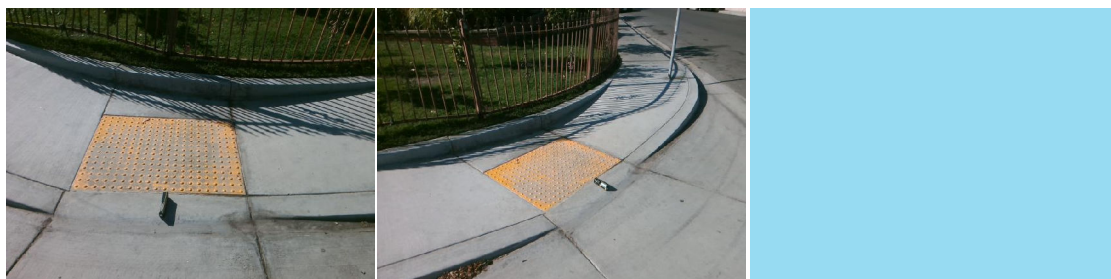
| Compliance | Description | Data | Compliance | Description | Data |
| N/A | Ramp Length LT (in) | 104 | N/A | Ramp Length RT (in) | 110 |
| Yes | Ramp Width LT (in) | 58 | Yes | Ramp Width RT (in) | 52 |
| Yes | Ramp Run Slope LT (%) | 6.6 | Yes | Ramp Run Slope RT (%) | 5.7 |
| Yes | Ramp Cross Slope LT (%) | 0.8 | Yes | Ramp Cross Slope RT (%) | 0.9 |
