# Access Compliance Report Public Rights-of-Way (Curb Ramps)

Main Street: FILLMORE\_DR Cross Street: NEARING\_DR Location: SE

ADA ID: RPAT211124135034 Ramp Type: Type 4 - Parallel Initial Pass/Fail: Pass Overall Compliance: Yes Severity Score: 0

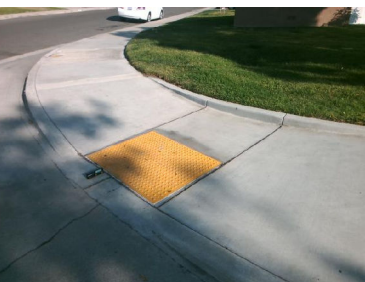
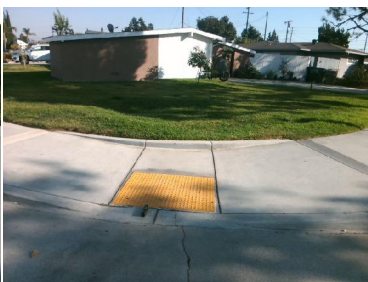
| Compliance | Description | Data | Compliance | Description | Data |
|---|---|---|---|---|---|
| Yes | Overall Surface Condition | Acceptable | | | |

Possible Solutions:

N/A
