# Access Compliance Report Public Rights-of-Way (Curb Ramps)

| Main Street: ARTHUR_DR | | Cross Street: FILLMORE_DR | | Location: | SW |
| ADA ID: RPAT211124141452 | Ramp Type: Type 4 - Parallel | Initial Pass/Fail: Pass | Overall Compliance: No | Severity Score: | 2 |

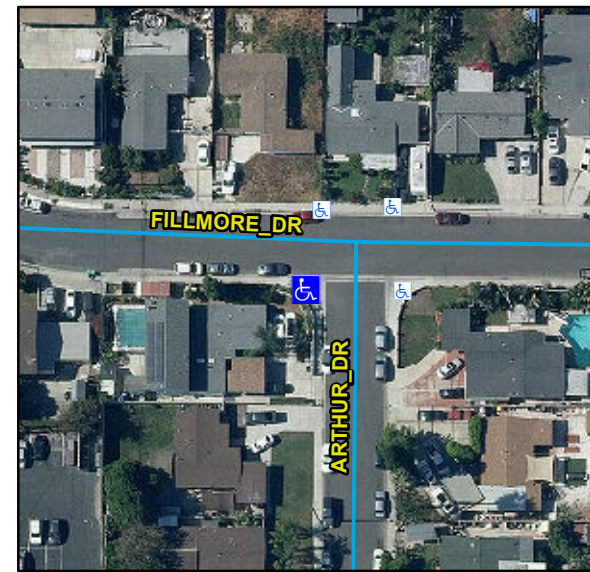
| Compliance | Description | Data | Compliance | Description | Data |
|---|---|---|---|---|---|
| Yes | Gutter Ponding | No | No | Curb Slope | 8.9 |

Possible Solutions:

Remove & Replace Curb Slope.

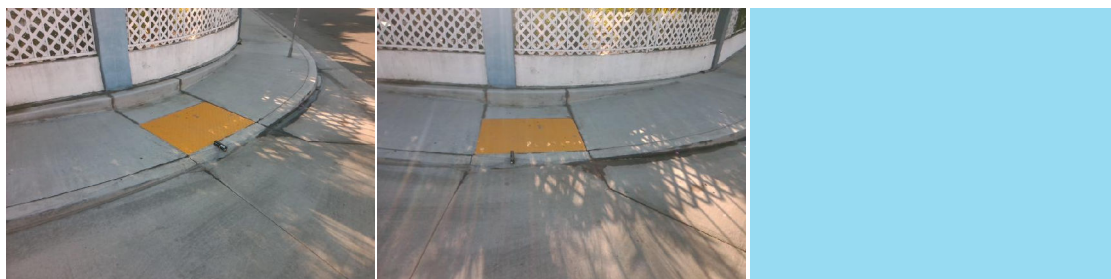
| Compliance | Description | Data | Compliance | Description | Data |
|---|---|---|---|---|---|
| Yes | Ramp Run Slope LT (%) | 6.2 | Yes | Ramp Run Slope RT (%) | 5.2 |
| Yes | Ramp Cross Slope LT (%) | 0.5 | Yes | Ramp Cross Slope RT (%) | 2 |
