# Access Compliance Report Public Rights-of-Way (Curb Ramps)

Main Street: POES\_ST Cross Street: AUGUSTA\_DR Location: SW

ADA ID: RPAT211124144510 Ramp Type: Type 4 - Parallel Initial Pass/Fail: Pass Overall Compliance: Yes Severity Score: 0

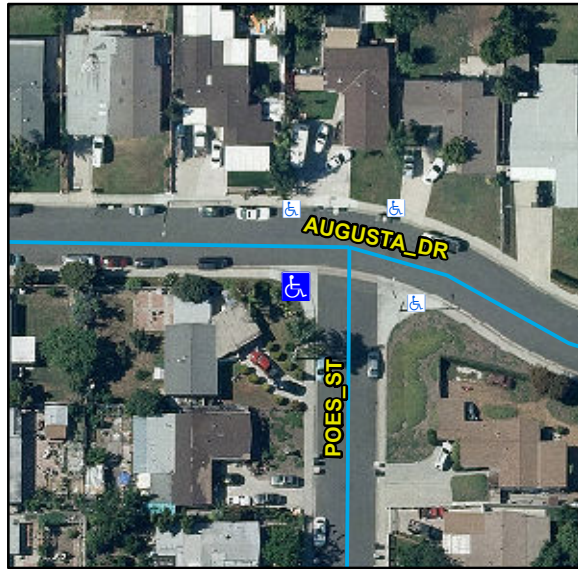
## Field Measurements/Component Compliance

Possible Solutions:

N/A

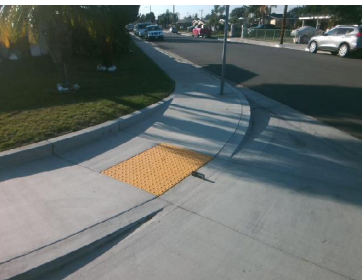
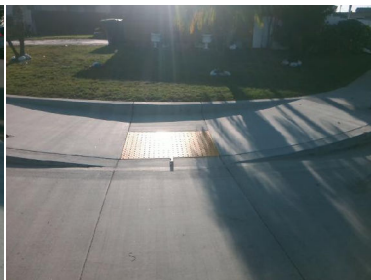
| Compliance | Description | Data | Compliance | Description | Data |
|---|---|---|---|---|---|
| Yes | Overall Surface Condition | Acceptable | | | |
