# Access Compliance Report Public Rights-of-Way (Curb Ramps)

Main Street: BRIARWOOD\_ST Cross Street: CHAPMAN\_AVE Location: SW

ADA ID: RPAT211130121150 Ramp Type: Type 4 - Parallel Initial Pass/Fail: Fail Overall Compliance: No Severity Score: 16

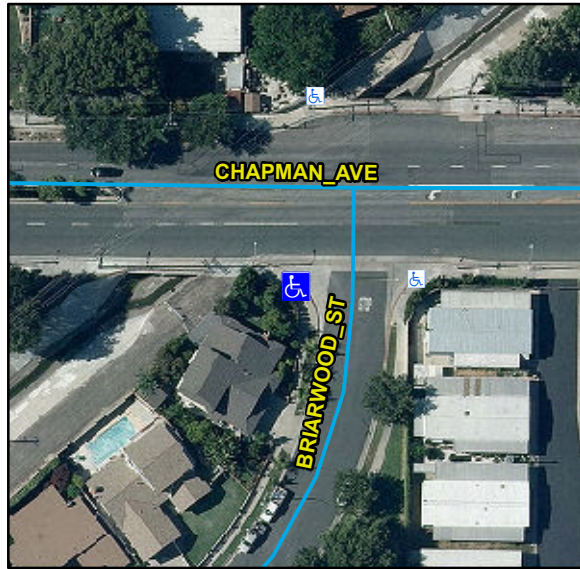
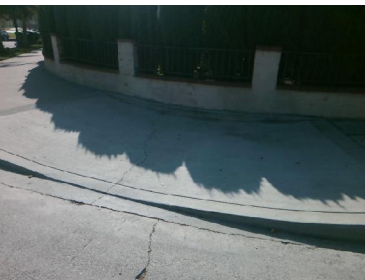
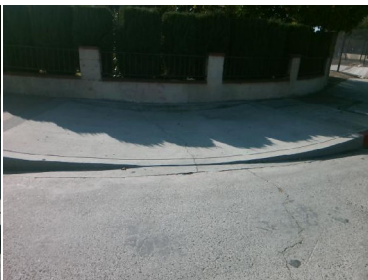
| Compliance | Description | Data | Compliance | Description | Data |
|---|---|---|---|---|---|
| No | Ramp Run Slope LT (%) | 9.5 | Yes | Ramp Run Slope RT (%) | 2.2 |
| Yes | Ramp Cross Slope LT (%) | 1.9 | No | Ramp Cross Slope RT (%) | 2.9 |
| No | Gutter Lip Height (in) | 2 | | Road Run Slope (%) | 2.2 |

Remove & Replace Curb Ramp With Two New Directional Ramps or Equivalent. Grind Gutter Lip.
