# Access Compliance Report Public Rights-of-Way (Curb Ramps)

Main Street: CHAPMAN\_AVE Cross Street: BEACH\_BLVD Location: NW

ADA ID: RPAT211130124405 Ramp Type: Type 4 - Parallel Initial Pass/Fail: Pass Overall Compliance: No Severity Score: 2

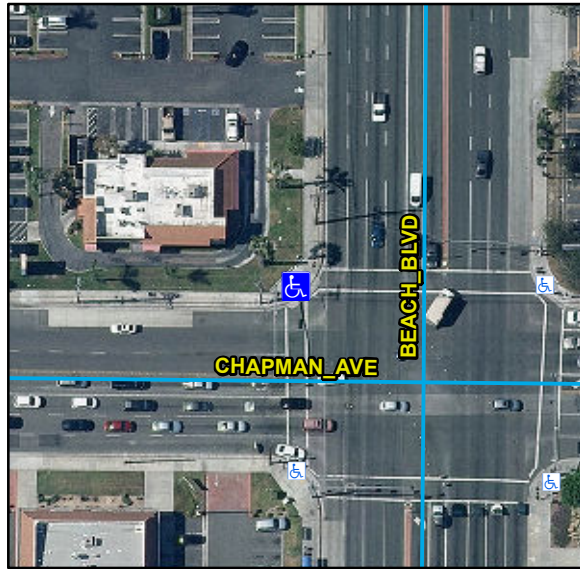
| Compliance | Description | Data | Compliance | Description | Data |
|---|---|---|---|---|---|
| Yes | Ramp Cross Slope LT (%) | 0.7 | No | Ramp Cross Slope RT (%) | 2.7 |
| No | Landing Run Slope (%) | 2.3 | Yes | DWS Full Width | Yes |

Remove & Replace Landing. Remove & Replace Sidewalk.

R304.5.3, R304.2.2-Perp, R304.3.2-Para, STD 1115
