# Access Compliance Report Public Rights-of-Way (Curb Ramps)

Main Street: LOCH\_LOMOND\_RD Cross Street: CHESNEY\_DR Location: NW

ADA ID: RPAT211201084912 Ramp Type: Type 1 - Perpendicular Diagonal Initial Pass/Fail: Pass Overall Compliance: No Severity Score: 14

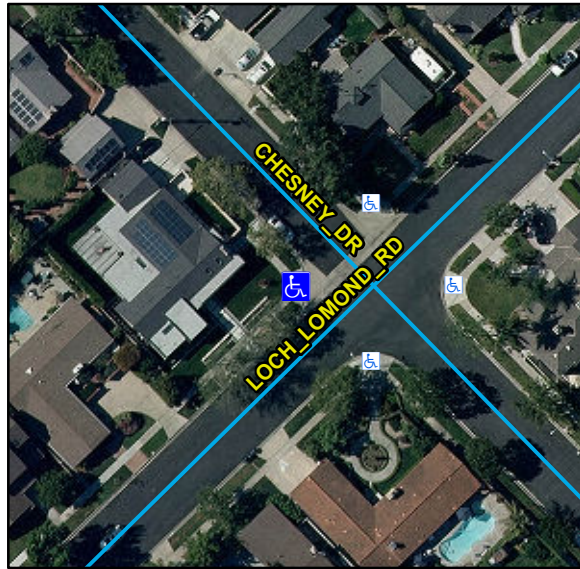
| Compliance | Description | Data | Compliance | Description | Data |
|---|---|---|---|---|---|
| No | Landing Run Slope (%) | 2.7 | N/A | Flare Traversable RT | No |
| Yes | Landing Cross Slope (%) | 0.5 | No | DWS Provided | No |
| Yes | Gutter Ponding | No | No | Curb Slope | 6.5 |

Remove & Replace Curb Ramp With Two New Directional Ramps or Equivalent.
