# Access Compliance Report Public Rights-of-Way (Curb Ramps)

Main Street: CHESNEY\_DR Cross Street: MARTHA\_ANN\_DR Location: SW

ADA ID: RPAT211201092908 Ramp Type: Type 1 - Perpendicular Diagonal Initial Pass/Fail: Pass Overall Compliance: No Severity Score: 14

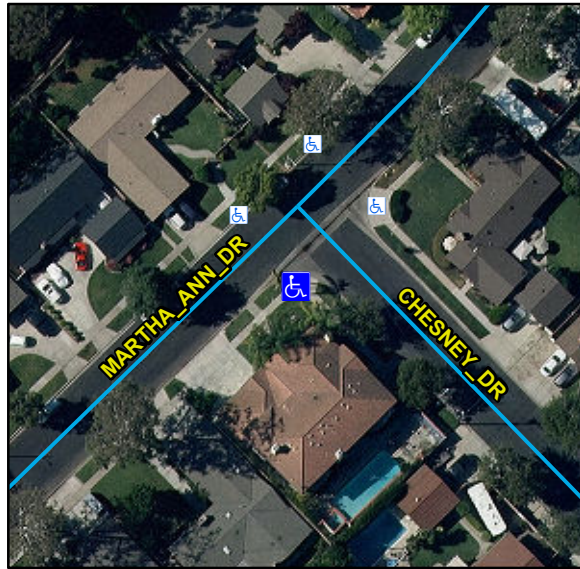
| Compliance | Description | Data | Compliance | Description | Data |
|---|---|---|---|---|---|
| No | Landing Cross Slope (%) | 2.8 | No | DWS Provided | No |
| Yes | Overall Surface Condition: Acceptable | | No | Perp Joint Present | No |

Remove & Replace Curb Ramp With Two New Directional Ramps or Equivalent.
