# Access Compliance Report Public Rights-of-Way (Curb Ramps)

Main Street: SHAKESPEARE\_DR Cross Street: WEMBLEY\_RD Location: N

ADA ID: RPAT211201101618 Ramp Type: Type 1 - Perpendicular Diagonal Initial Pass/Fail: Pass Overall Compliance: No Severity Score: 16

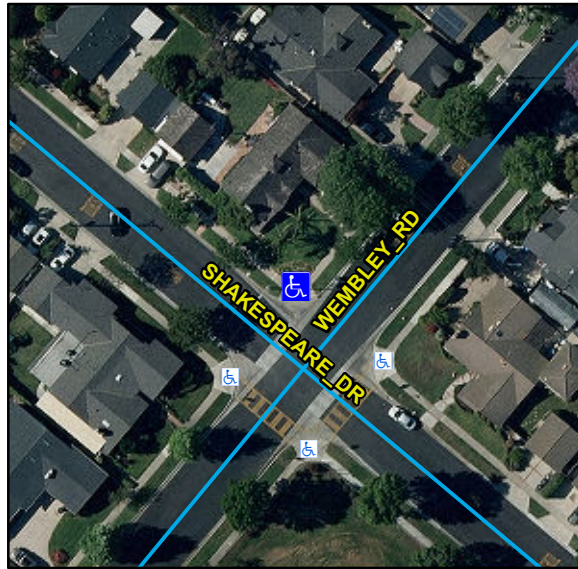
| Compliance | Description | Data | Compliance | Description | Data |
|---|---|---|---|---|---|
| No | Landing Run Slope (%) | 2.2 | N/A | Flare Traversable RT | Yes |
| Yes | Landing Cross Slope (%) | 1 | No | DWS Provided | No |
| No | Gutter Cross Slope (%) | 2.2 | | | |

Remove & Replace Curb Ramp With Two New Directional Ramps or Equivalent. Remove & Replace Gutter.

R204.3, R304.2.1, R304.2.2-Perp, R304.3.2-Para, R305, R304.5.3, STD 1115
