# Access Compliance Report Public Rights-of-Way (Curb Ramps)

Main Street: MARTHA\_ANN\_DR Cross Street: SHAKESPEARE\_DR Location: E

ADA ID: RPAT211201103949 Ramp Type: Type 1 - Perpendicular Diagonal Initial Pass/Fail: Fail Overall Compliance: No Severity Score: 15

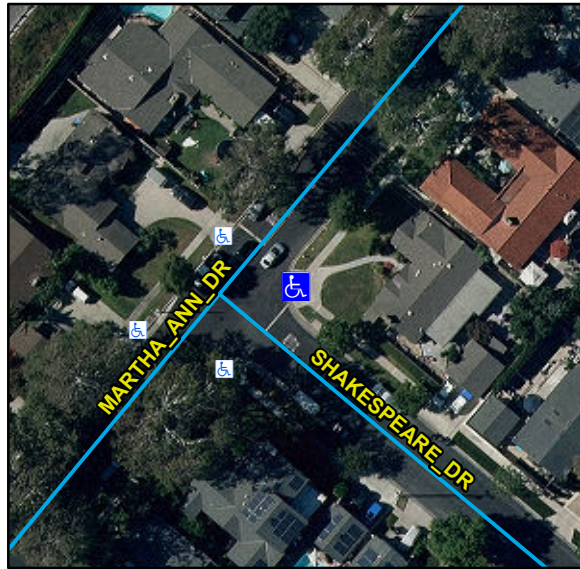
| Compliance | Description | Data | Compliance | Description | Data |
|---|---|---|---|---|---|
| No | Ramp Run Slope (%) | 9.1 | N/A | Flare Slope LT (%) | N/A |

Remove & Replace Curb Ramp With Two New Directional Ramps or Equivalent.

R304.2.2, STD 1115
