# Access Compliance Report Public Rights-of-Way (Curb Ramps)

Main Street: SILVERWOOD\_DR Cross Street: WEMBLEY\_RD Location: N

ADA ID: RPAT211201111521 Ramp Type: Type 1 - Perpendicular Diagonal Initial Pass/Fail: Pass Overall Compliance: No Severity Score: 14

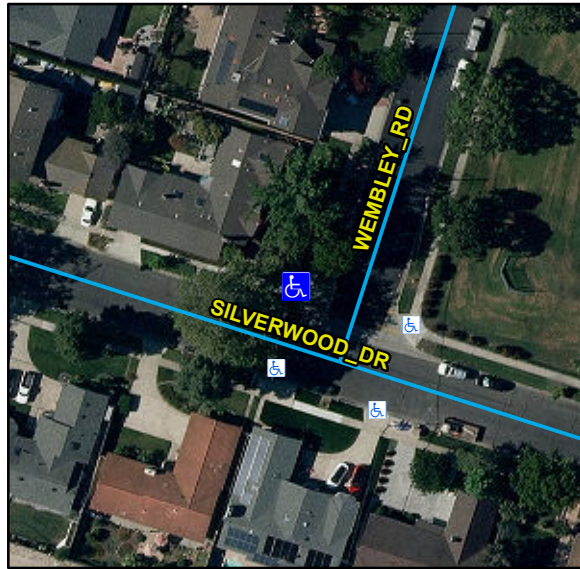
| Compliance | Description | Data | Compliance | Description | Data |
|---|---|---|---|---|---|
| No | Landing Run Slope (%) | 2.3 | N/A | Flare Traversable RT | No |
| Yes | Landing Cross Slope (%) | 2 | No | DWS Provided | No |

Remove & Replace Curb Ramp With Two New Directional Ramps or Equivalent.

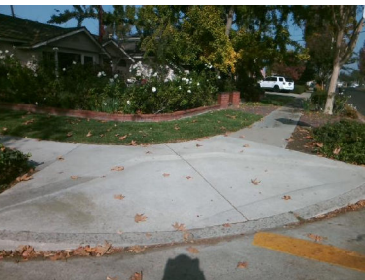
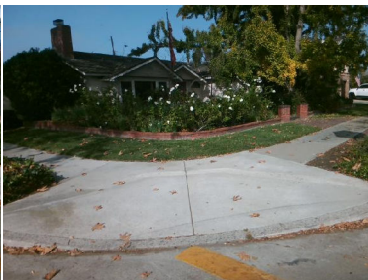
| Compliance | Description | Data | Compliance | Description | Data |
|---|---|---|---|---|---|
| Yes | Overall Surface Condition: Acceptable | | No | Perp Joint Present | No |
