# Access Compliance Report Public Rights-of-Way (Curb Ramps)

Main Street: LOCH\_LOMOND\_RD Cross Street: SHAKESPEARE\_DR Location: E

ADA ID: RPAT211201113915 Ramp Type: Type 1 - Perpendicular Diagonal Initial Pass/Fail: Fail Overall Compliance: No Severity Score: 2

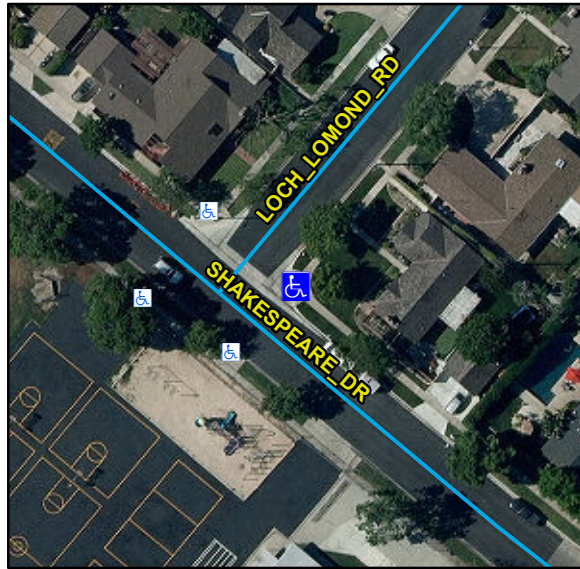
| Compliance | Description | Data | Compliance | Description | Data |
|---|---|---|---|---|---|
| No | Ramp Cross Slope (%) | 2.7 | N/A | Flare Traversable LT | N/A |

Remove & Replace Curb Ramp With Two New Directional Ramps or Equivalent.

R204.3, R304.5.3, STD 1115
