# Access Compliance Report Public Rights-of-Way (Curb Ramps)

Main Street: KITTRICK\_DR Cross Street: BASKERVILLE\_RD Location: N

ADA ID: RPAT211202090709 Ramp Type: Type 1 - Perpendicular Diagonal Initial Pass/Fail: Fail Overall Compliance: No Severity Score: 5

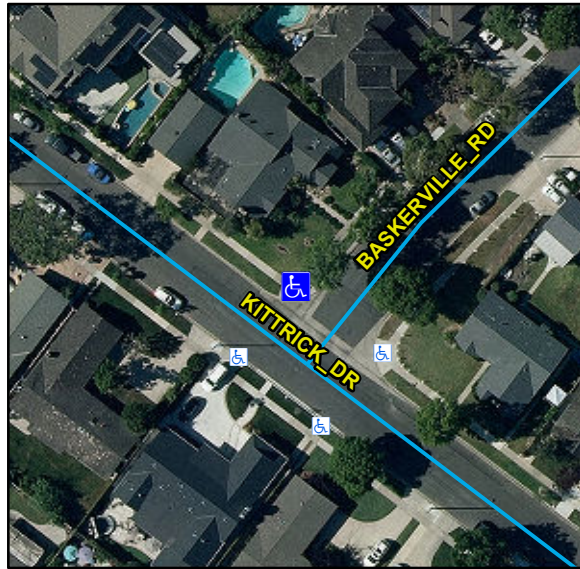
| Compliance | Description | Data | Compliance | Description | Data |
|---|---|---|---|---|---|
| No | Ramp Width (in) | 46 | | | N/A |
| No | Ramp Cross Slope (%) | 2.3 | N/A | Flare Traversable LT | N/A |

Remove & Replace Curb Ramp With Two New Directional Ramps or Equivalent.

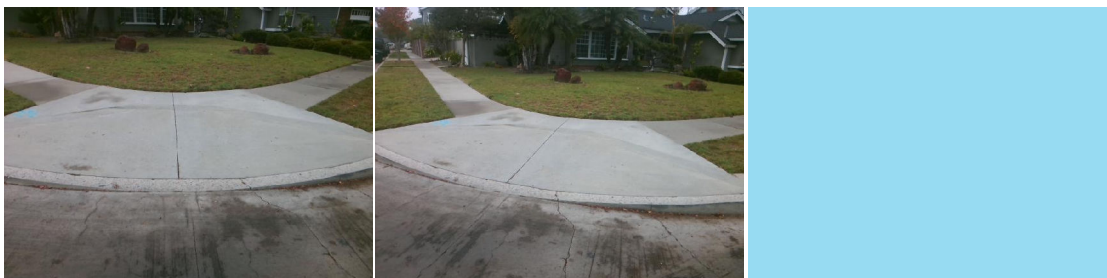
| Compliance | Description | Data | Compliance | Description | Data |
|---|---|---|---|---|---|
| Yes | Overall Surface Condition: Acceptable | | No | Perp Joint Present | No |
| | Cross Gutter Present? | Yes | | Spandrel Present? | Yes |
